TEA FIRE SEWER STUBS

January 2009

TEA FIRE LATERAL
ABANDONMENT PROJECT

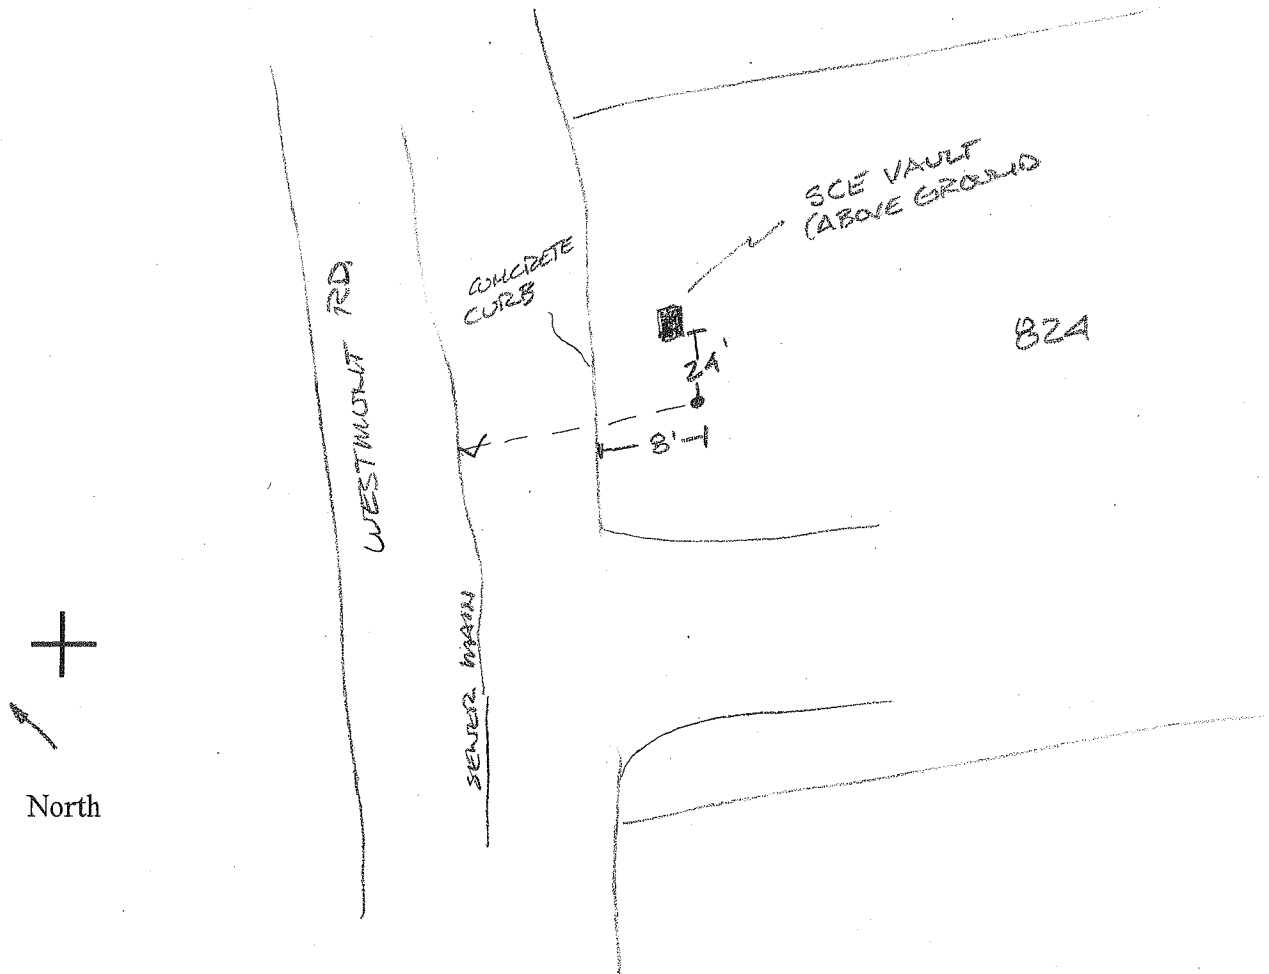
- Date: 12-23-08
- Property Address: 824
- Location/Address of actual excavation (also see diagram attached): SOME
- Size & material type of sewer main: N/A
- Size & material type of lateral: 3"
- Depth of Wye connection: N/A
- Distance of lateral from centerline of downstream manhole: 200' 6"
- Excavation dimensions: N/A
- Brief description of the site (utility conflict/traffic/soil type/other issues): NONE

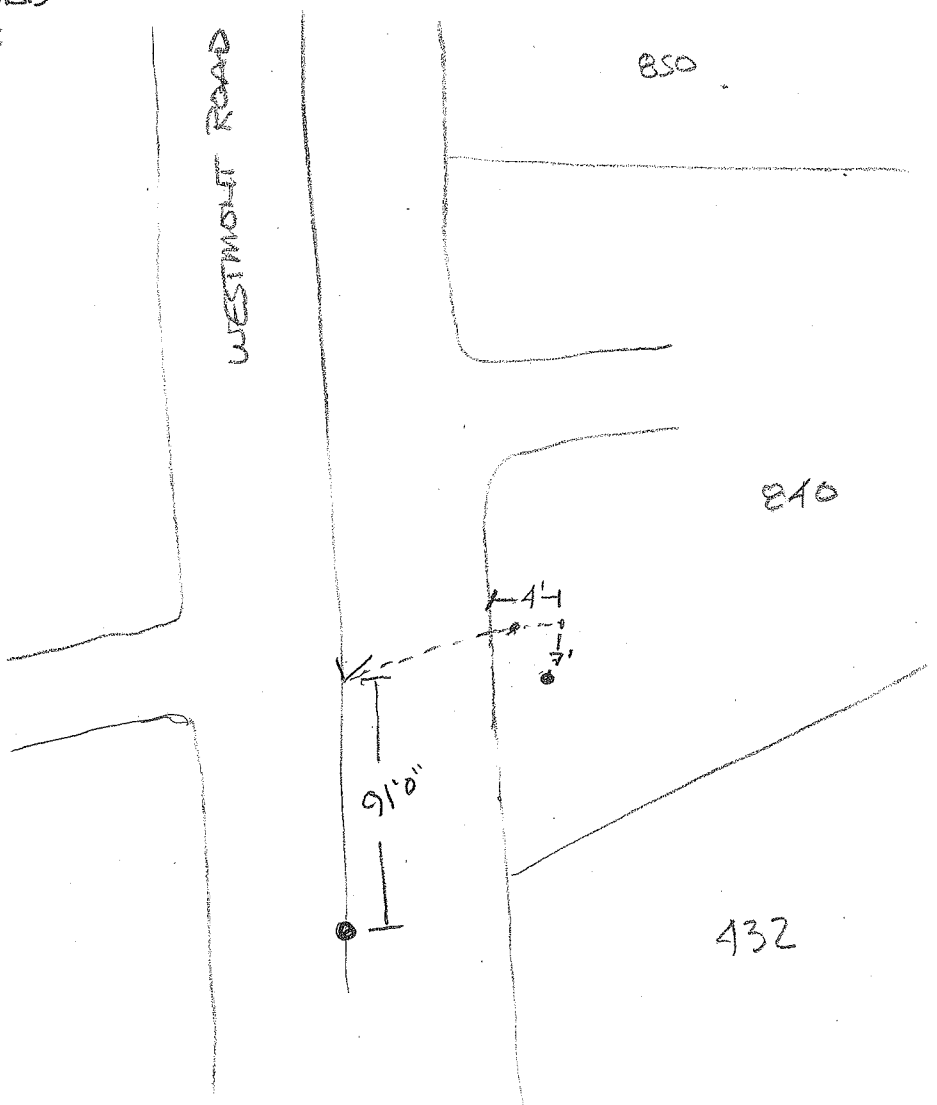
- Date: 12-23-08
- Property Address: 850 WESTMOLT RD.
- Location/Address of actual excavation (also see diagram attached): SAME
- Size & material type of sewer main: N/A
- Size & material type of lateral: 4" SDR
- Depth of Wye connection: 6'6"
- Distance of lateral from centerline of downstream manhole:
- Excavation dimensions: N/A
- Brief description of the site (utility conflict/traffic/soil type/other issues): MANY UTILITIES DIRECTLY ABOVE SEWER LATERAL

4' BEHIND FACE OF CURB
7' NORTH OF CONCRETE
LIGHT STANDARD

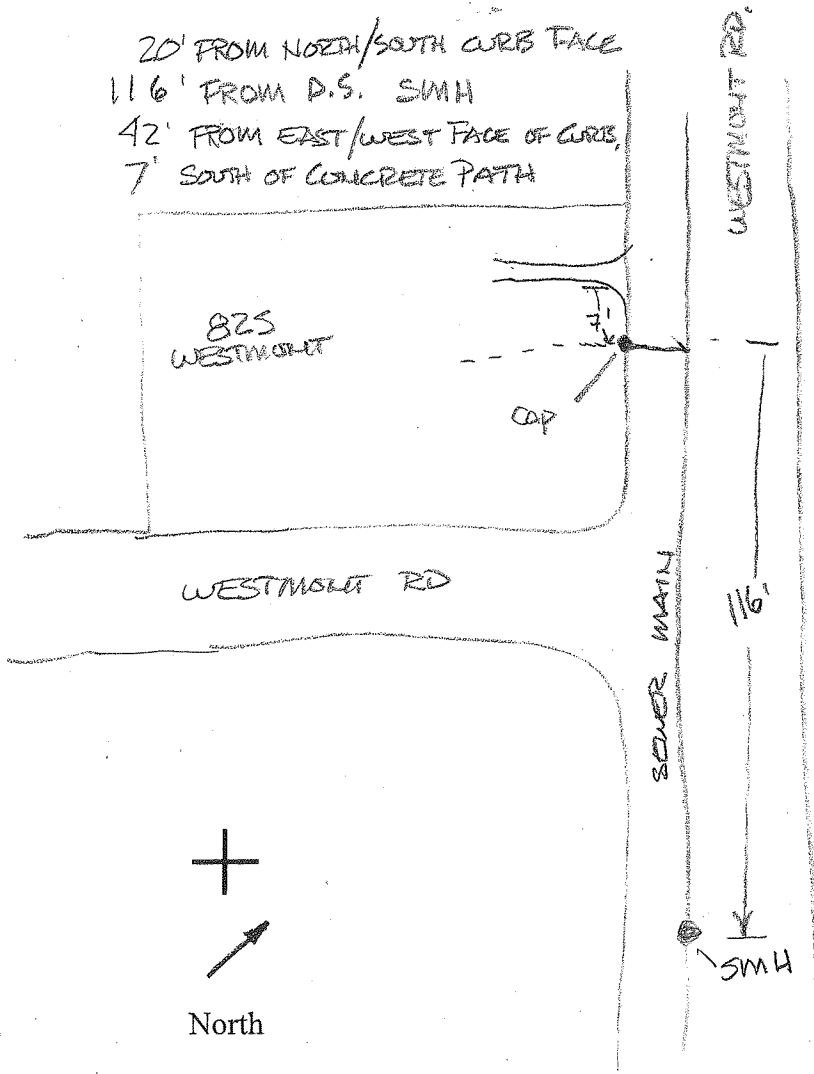
- Date: 12-29-08
- Property Address: 825 WESTMOUNT
- Location/Address of actual excavation (also see diagram attached):
- Size & material type of sewer main: H/A
- Size & material type of lateral: 4" PVC (CMU) & 3" ABS (PROP)
- Depth of Wye connection: 6'6"
- Distance of lateral from centerline of downstream manhole: 116'
- Excavation dimensions:
- Brief description of the site (utility conflict/traffic/soil type/other issues):

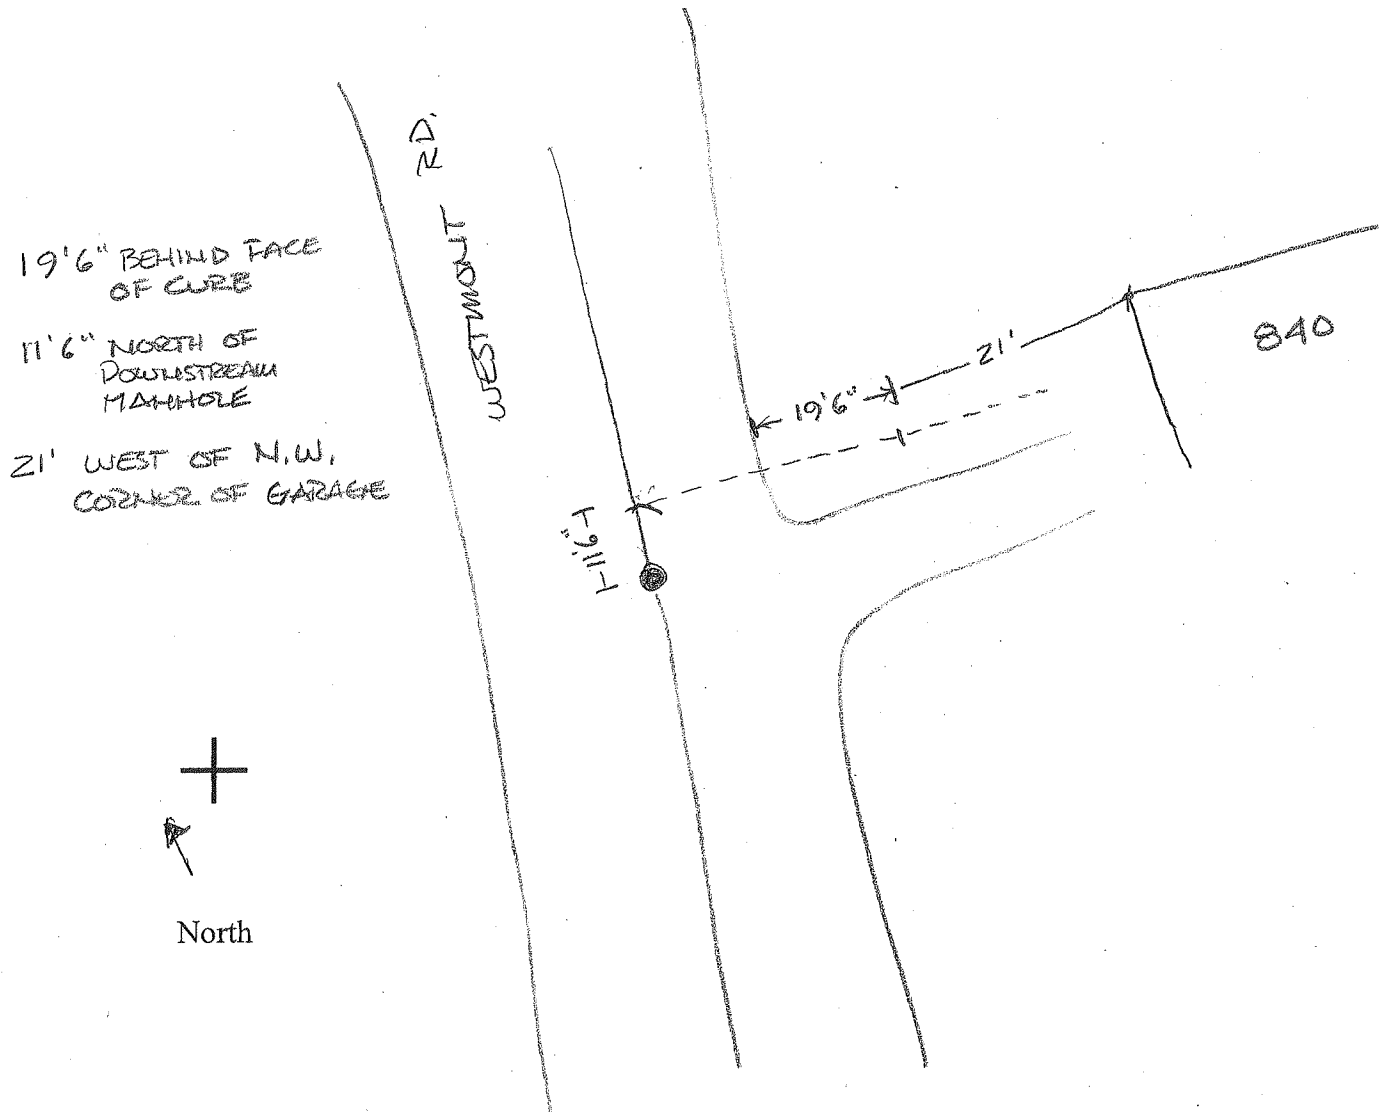
- Date: 12-23-08
- Property Address: 840 WESTMOUNT RD
- Location/Address of actual excavation (also see diagram attached):
- Size & material type of sewer main:
- Size & material type of lateral: 3" ABS
- Depth of Wye connection: 5'
- Distance of lateral from centerline of downstream manhole: 11' 6"
- Excavation dimensions: 3 x 4
- Brief description of the site (utility conflict/traffic/soil type/other issues): NONE

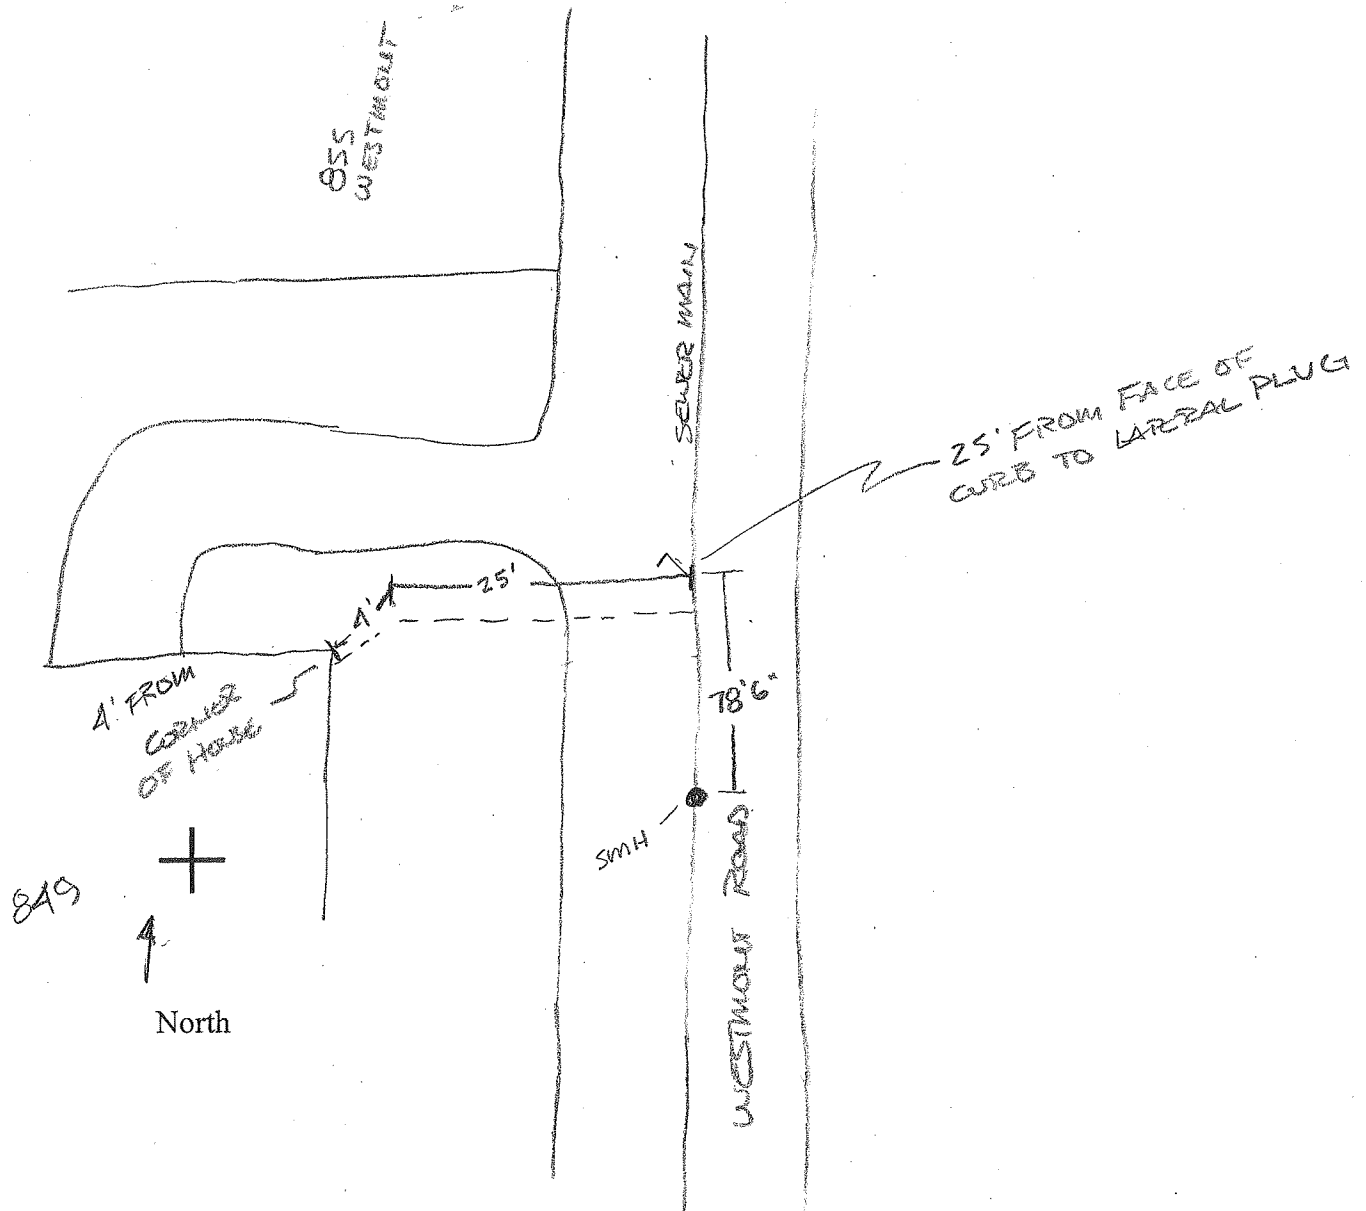
- Date: 12-23-08
- Property Address: 849 WESTMONT ROAD (CHECK TO SEE IF ON LIST)
- Location/Address of actual excavation (also see diagram attached): SAME
- Size & material type of sewer main: N/A
- Size & material type of lateral: 3" ABS
- Depth of Wye connection: N/A
- Distance of lateral from centerline of downstream manhole:
- Excavation dimensions: N/A
- Brief description of the site (utility conflict/traffic/soil type/other issues): NONE

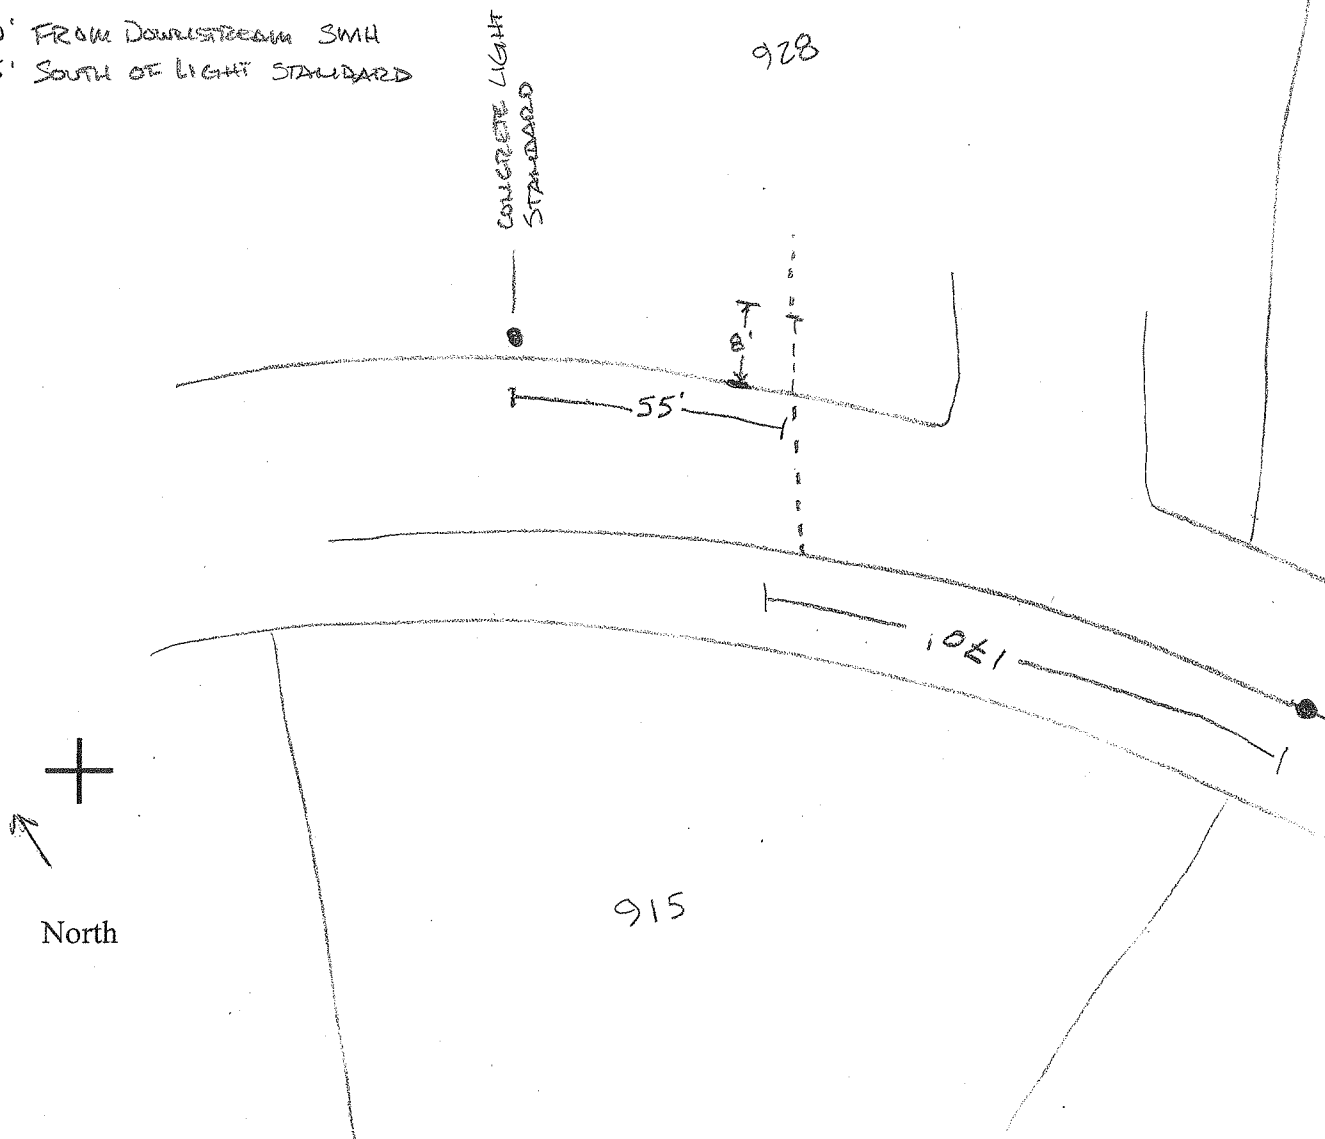
- Date: 12-23-08
- Property Address: 928 WESTMONT
- Location/Address of actual excavation (also see diagram attached):
- Size & material type of sewer main: N/A
- Size & material type of lateral: 4" SDR
- Depth of Wye connection: 3' 6"
- Distance of lateral from centerline of downstream manhole: 170'
- Excavation dimensions: 3x3
- Brief description of the site (utility conflict/traffic/soil type/other issues): NONE

8' BEHIND CURB
 170' FROM DOWNSTREAM SMH
 55' SOUTH OF LIGHT STANDARD

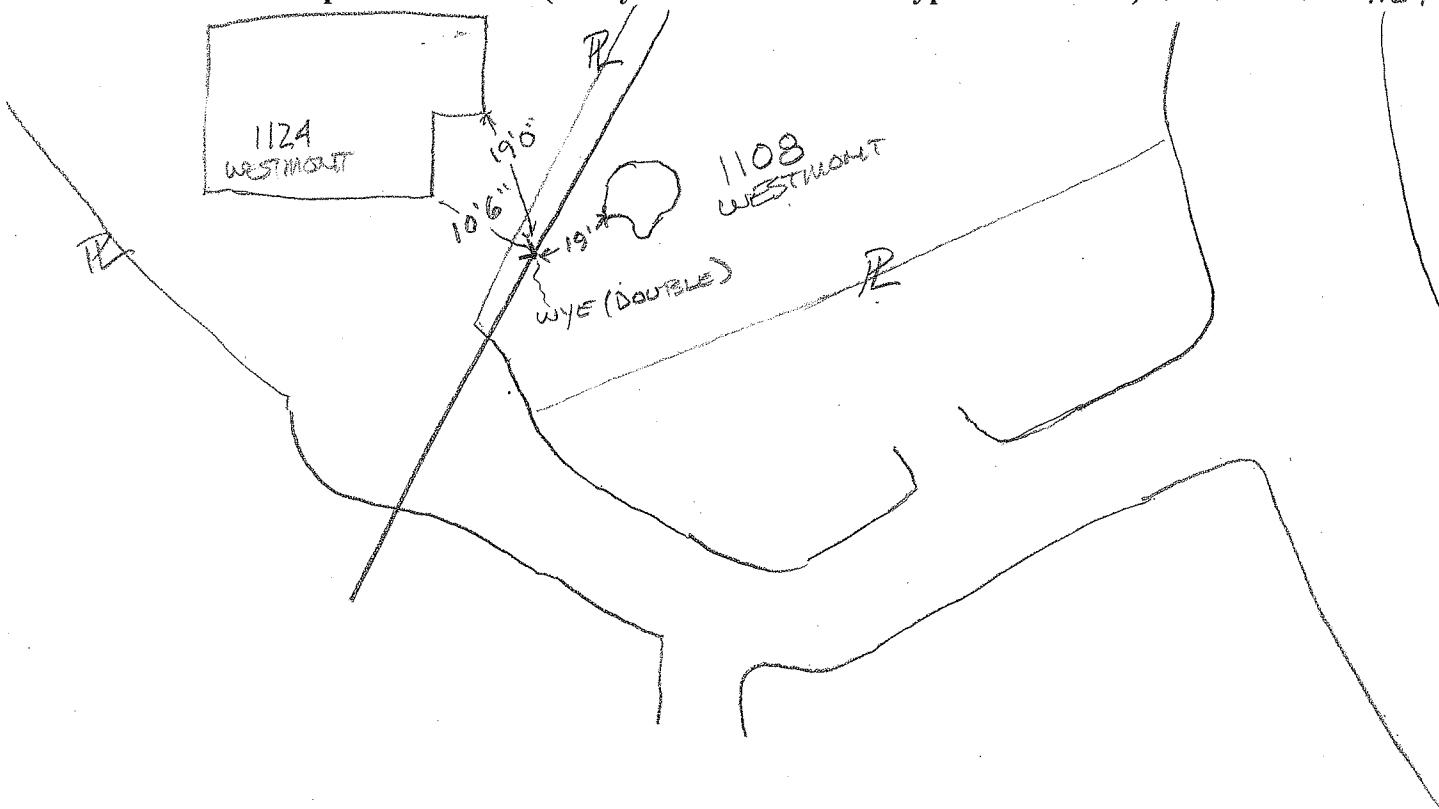
- Date: 12-30-08
- Property Address: 1108 WESTMONT RD.
- Location/Address of actual excavation (also see diagram attached): SEE BELOW
- Size & material type of sewer main:
- Size & material type of lateral: 4"
- Depth of Wye connection: 6' 6"
- Distance of lateral from centerline of downstream manhole: N/A
- Excavation dimensions: 3 X 3
- Brief description of the site (utility conflict/traffic/soil type/other issues): DOUBLE WYE - 1108 - 1124

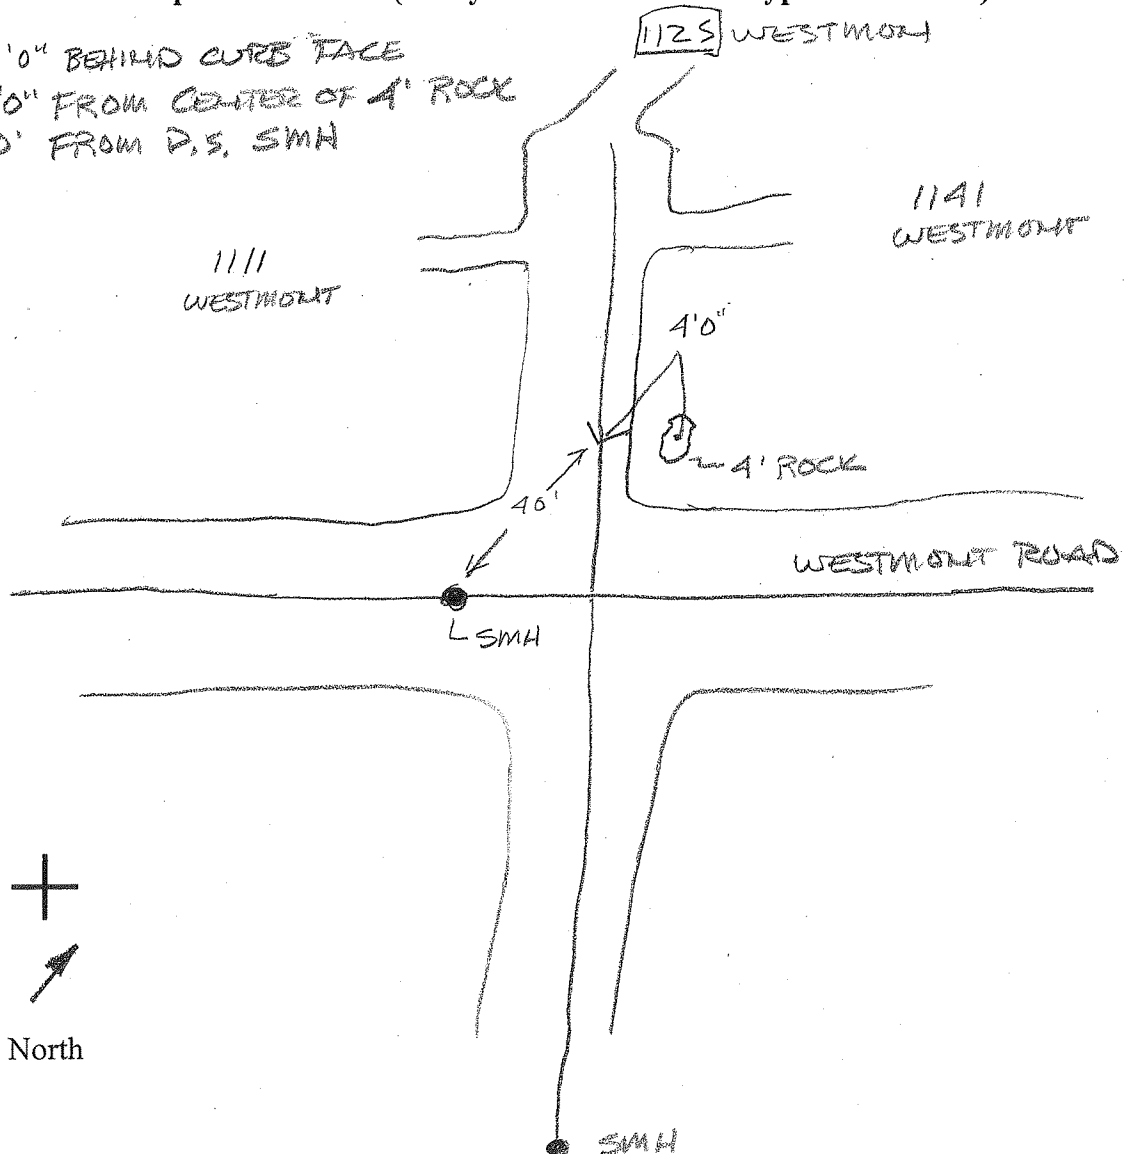
- Date: 12-30-08
- Property Address: 1125 WESTMONT
- Location/Address of actual excavation (also see diagram attached): SEE BELOW
- Size & material type of sewer main: N 1/2
- Size & material type of lateral: 4" PVC
- Depth of Wye connection: 2'
- Distance of lateral from centerline of downstream manhole: 40'
- Excavation dimensions: 2x2
- Brief description of the site (utility conflict/traffic/soil type/other issues): EDGE OF PAVEMENT

14'0" BEHIND CURB FACE
 4'0" FROM CENTER OF 4' ROCK
 40' FROM D.S. SMH

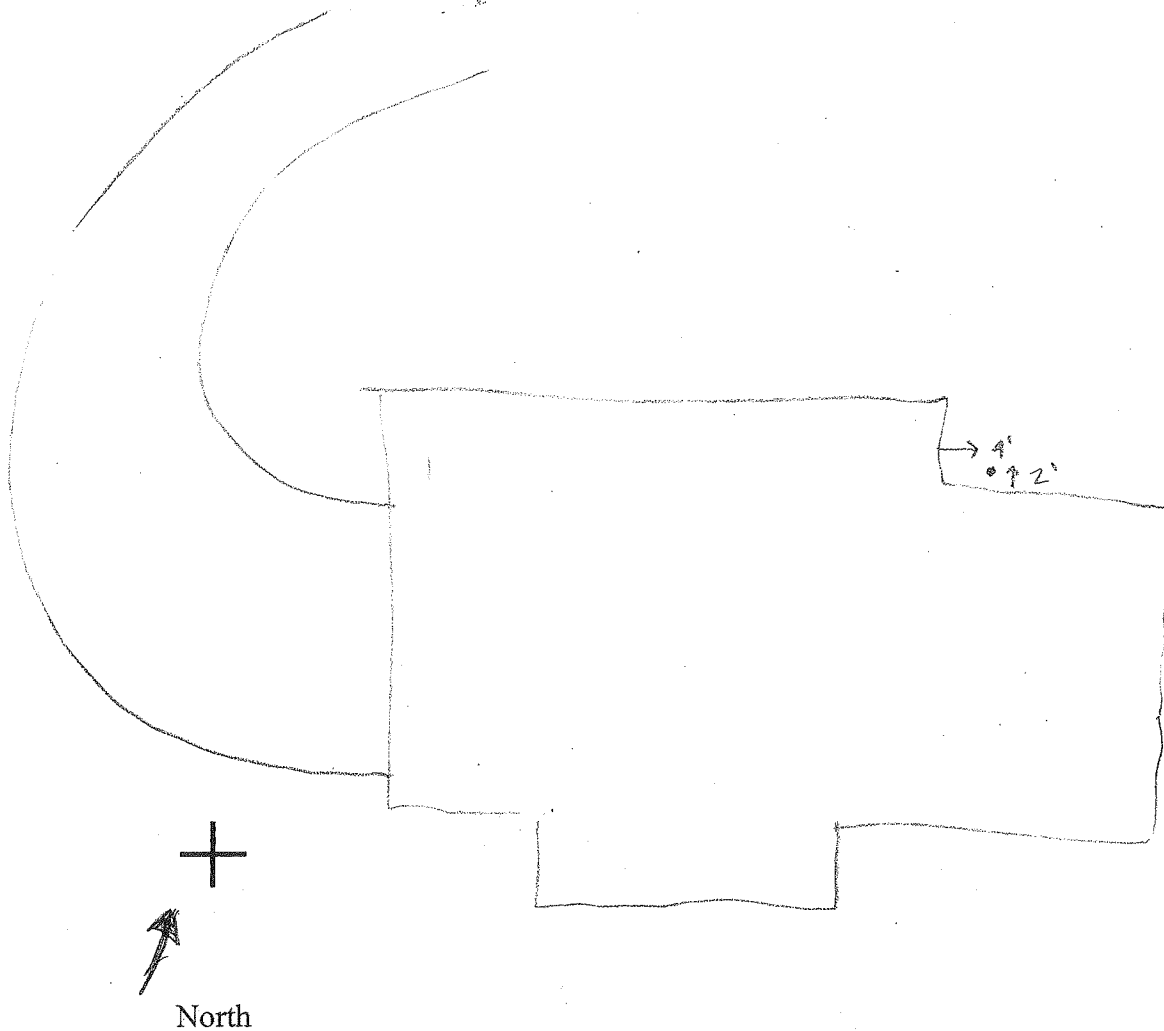
- Date: 12-29-08
- Property Address: 1132 WERTMONT
- Location/Address of actual excavation (also see diagram attached):
- Size & material type of sewer main: 14" / A
- Size & material type of lateral: 3" ABS
- Depth of Wye connection: 18"
- Distance of lateral from centerline of downstream manhole: N/A
- Excavation dimensions: 2x2
- Brief description of the site (utility conflict/traffic/soil type/other issues):
